**FIRE AND EXPLOSION GROUP
FACTUAL REPORT OF INVESTIGATION**

Fire and Explosion Group

Group Chairman's Factual Report

NTSB File # HWY-05-MH-035

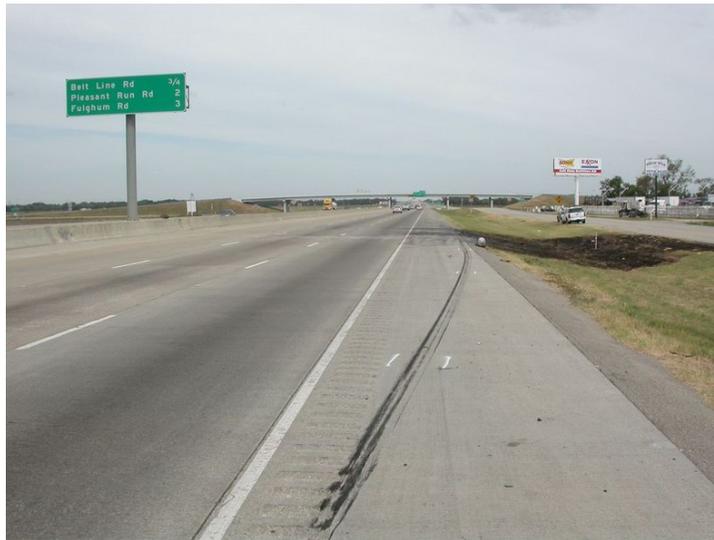
Figure 1: Site of the accident

The accident site was located on the right shoulder of I-45N, near the Beltline Road overpass (Figure 1). The road surface was stained by fire debris (Figure 2), and a grass fire had spread from the motorcoach east toward the service road. The concrete road surface appeared to have a localized area

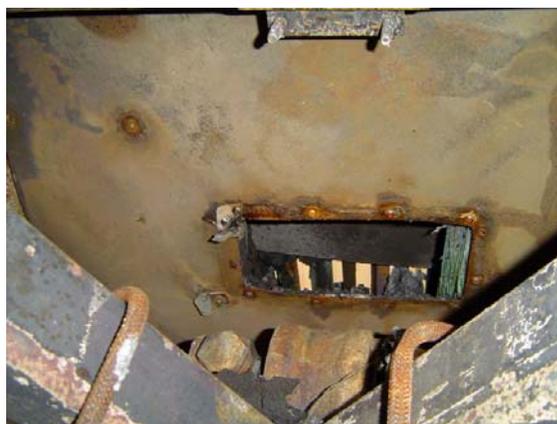
Figure 10: Access opening under motorcoach

Along the centerline between the left and right rear wheel wells, the fuel lines run beneath the passenger cabin floor along a service tunnel together with power steering and coolant lines (Figure 9). There are two fiberglass cover panels located underneath the motorcoach in the wheel well area. The cover panels facilitate access to this service tunnel from the outside. The rearmost cover was consumed by fire (Figure 10), creating an opening to the passenger cabin floor, and exposing the fuel lines (which were consumed by fire) and other lines. The other lines were metallic and remained intact. The forward access cover was charred but remained in place.

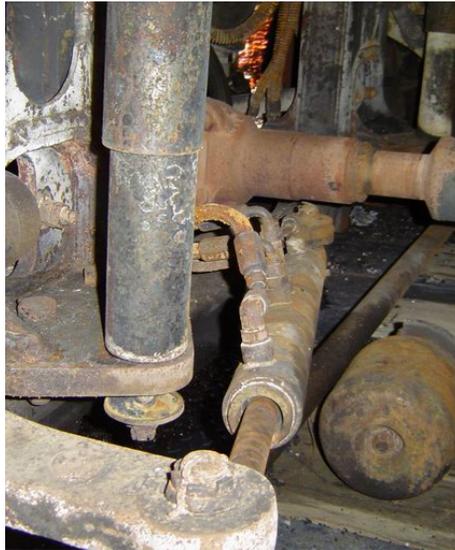
Figure 11: RAS cylinder

The accident motorcoach was equipped with an active steering TAG axle assembly. The hydraulic lines connected to the TAG axle power steering cylinder were examined (Figure 11). There are three hydraulic lines that link the rear axel steering (RAS) cylinder to the rest of the power steering system. These three lines are intact from their connection on the steering cylinder up to the fittings that end these lines. The fittings at the ends of these lines would attach to an aluminum manifold which was missing (Figure 12). A solidified mass of melted aluminum was found on top of the transmission just below the location where the manifold was originally installed. In the engine compartment the power steering hydraulic lines were examined. The metallic return line coming from the front of the motorcoach along the tunnel was connected to the back of the manifold and appeared intact (Figure 6). The braided steel return line from the manifold to the power steering fluid reservoir was also intact. The braided steel line from the reservoir to the power steering pump showed signs of chaffing at the clamp location (Figure 13). Visual evidence of leaks in this area, in the form of stains, was evident on neighboring engine compartment components. From the power steering pump, the braided steel supply line was intact up to its connection at the manifold. At the manifold, the supply line transitions to metallic pipe and is directed back to the service tunnel along the motorcoach centerline.

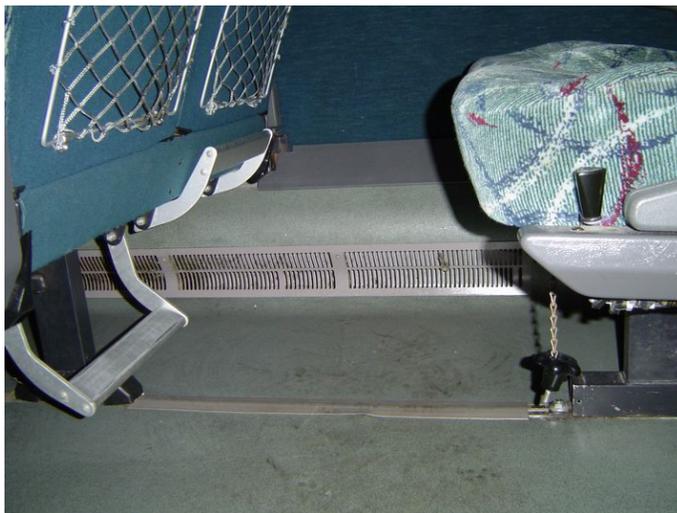
Figure 14: Return vent grill in exemplar bus

The HVAC system of the motorcoach was mostly destroyed by fire. The motorcoach was equipped with an HVAC system for the passenger compartment and a separate smaller system for the driver's area. The HVAC system for the passenger compartment was symmetrical along the centerline of the motorcoach with a separate controller for each side. In the passenger area, the supply air was introduced into the cabin via overhead diffuser nozzles located on the underside of the luggage rack (Figure 30). The return air was drawn into the return ducts through vent grills (Figure 14). The return ducts were located at floor level, spanning the length of the motorcoach and were built into the side walls. These return ducts were aluminum extrusions. Sections of these return ducts were missing and their adjoining parts showed signs of severe heat exposure. These sections were located above the wheel well areas on both sides of the motorcoach (Figure 15, 28, 29).

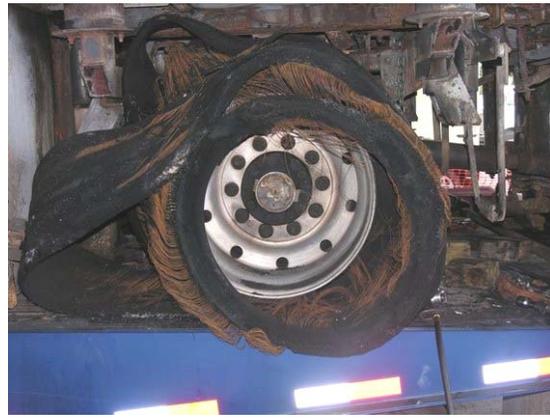
Figure 20: Left side drive axle outer

The drive axle wheels on the left side were not removed from the vehicle at the time of the inspection, so only a limited examination was possible. The left side tag axle rim appeared intact. This was a steel rim. Approximately a 12" footprint of tire was unaffected by fire. The drive axle inner tire (Figure 19) was mounted on a steel rim which appeared intact. Approximately a 14" footprint of tire was unaffected by fire. The remaining portion of tire was heavily damaged by fire. The tread separated from approximately the 3 o'clock thru 12 o'clock position (viewed from outboard side). Complete tread was visible around the tire. The drive axle outer tire (Figure 20) was mounted on an aluminum rim. The rim appeared intact. Approximately a 9" footprint of tire was unaffected by fire. The remaining portion of tire was heavily damaged by fire. The tread separated from approximately the 3 o'clock thru 9 o'clock position (viewed from outboard side). Complete tread was visible around the tire.

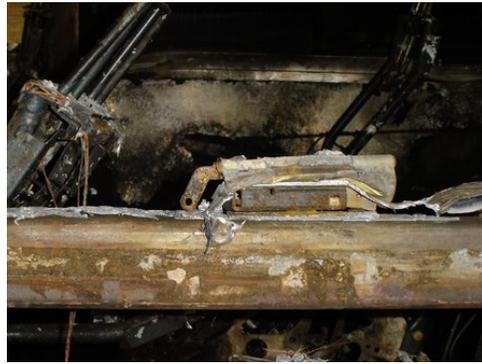
Figure 22: Window latch mechanism

All window frames were missing from the left side of the motorcoach. The steel window release pins (Figure 21) were in place and intact with no obvious signs of deformation. One exception was the forward release pin at the #2 window (counting from the front). This release pin was not the same type as all others, and appeared to be a Torx⁴ screw. All latch mechanisms were missing from the window release pins except for the forward mechanism at the #7 window, and both mechanisms from the #3 window were in place. One of the latch mechanisms from the #3 window is shown in Figure 22.

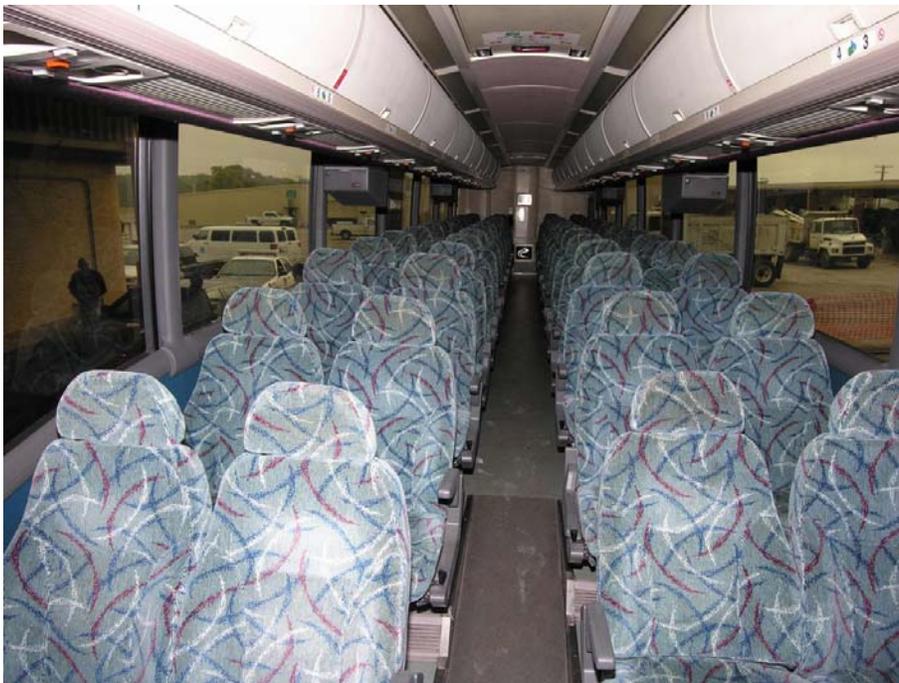
Figure 30: Interior of exemplar bus

The accident motorcoach contained 54 passenger seats distributed among two aisles (Figure 30). The passenger side aisle had 13 rows of seating plus a lavatory, and the driver's side aisle had 14 rows of seating. The seats consisted of upholstery covered foam padded backs and cushions over steel seat frames. The floor throughout the motorcoach was ½ inch thick plywood with a 0.1 inch thick vinyl covering. There were overhead luggage racks on both sides of the coach. An extruded aluminum frame spanned the length of the luggage rack with cast aluminum support ribs at points in between. The exposed surfaces of the luggage rack were extruded polyvinyl chloride (PVC). The ceiling at the extreme front and at the rear window area were fiberglass reinforced plastic. The main ceiling area was Xorel^{®7} FR over acrylonitrile butadiene styrene (ABS).
